AFRL-RX-WP-TR-2018-0080

EVALUATION OF A MELT INFILTRATED SIC/SIC CERAMIC MATRIX COMPOSITE

20 DECEMBER 2017
Final Report

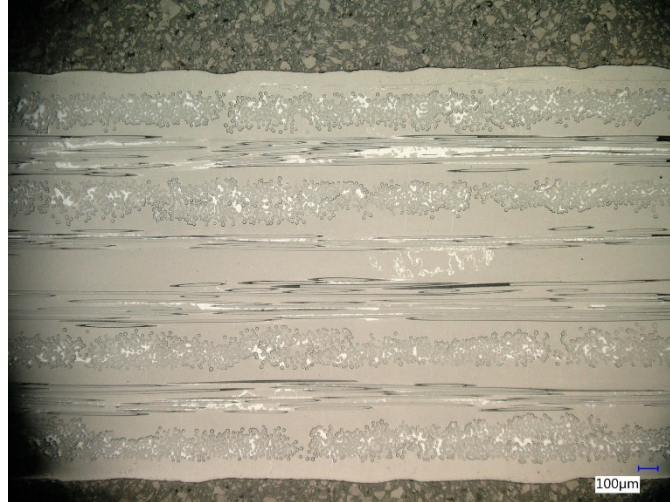
Figure 2. Optical micrograph of HiPerComp™ Gen 1.1 Hi-Nicalon/SiC (0/90)2s showing a 0/90 cross-section at 100×

An optical micrograph of the cross-section for the 0/90 orientation is shown in Figure 2 at a low magnification of 100×. The fibers appear circular for the 0° fiber plies and as cylinders for the 90° fibers. All eight plies can be easily identified in the image. Matrix-rich regions can be seen between all of the plies, and there are significant matrix-rich regions on both surfaces of the CMC. Figure 3 is an expanded view of Figure 2 and highlights the center section of the composite. From the image, the two 90° plies located at the center of the composite are clearly visible and the matrix region between the two center plies is very evident, even though these two plies are both 90°. Figure 4 is a 500× magnification image of the microstructure and focuses on one of the 0° plies, while Figure 5 is a much higher magnification (1000×) of a 0° tow. In Figure 5 one can see the fiber coating on the fibers, with the fibers near the outside of the tow having a thicker coating than those near the interior of the tow. The bright phase inside the fiber tows is residual silicon from the melt-infiltration process. The unreacted silicon fills up any voids or porosity. In this figure, one can also identify matrix cracks in the matrix-rich regions, which have also filled with silicon. It is the filling of pores and matrix cracks with silicon that results in a very dense matrix. Overall the composite microstructure is very uniform, and there is a complete lack of any observable porosity.

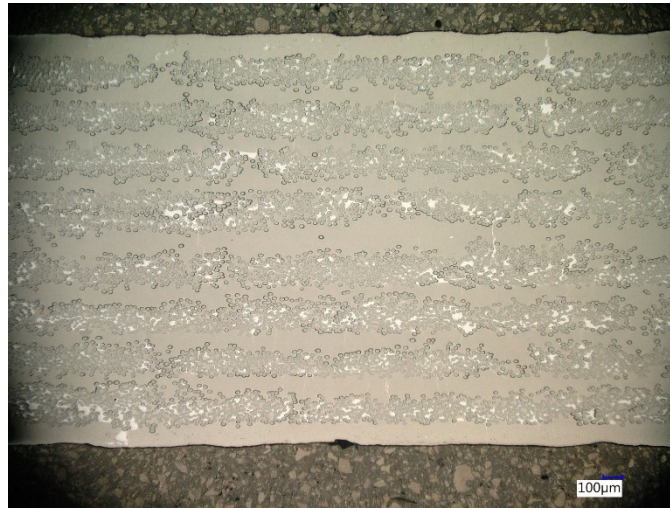
Figure 6. Optical micrograph of HiPerComp™ Gen 1.1 Hi-Nicalon/SiC (0/90)2s showing a ± 45 cross-section at 100×

A micrograph of the cross-section taken of the $\pm 45^\circ$ orientation is shown in Figure 6 at a low magnification of 100 \times . Since all fibers are oriented 45° to the polished surface, there is no fiber pull-out. The micrograph gives a true representation of the fiber distribution within the composite. Figure 7 is a 200 \times image of the 45° microstructure, and one can observe that the fiber volume fraction in each ply varies significantly along the width. Figure 8 is a 500 \times micrograph, and Figure 9 is a 1000 \times micrograph of the 45° microstructure. It is apparent that some fibers have a much thicker fiber coating than others, and that there are a significant number of silicon-rich areas that are 1 to 5 fiber diameters in size. In Figure 9, one can clearly see that there was a processing crack that ran horizontally through this fiber bundle and that it has completely filled with silicon. Even at this extremely high magnification, there is no sign of any

residual porosity or open-matrix cracks. It is this very dense matrix that gives this CMC very good high-temperature performance.

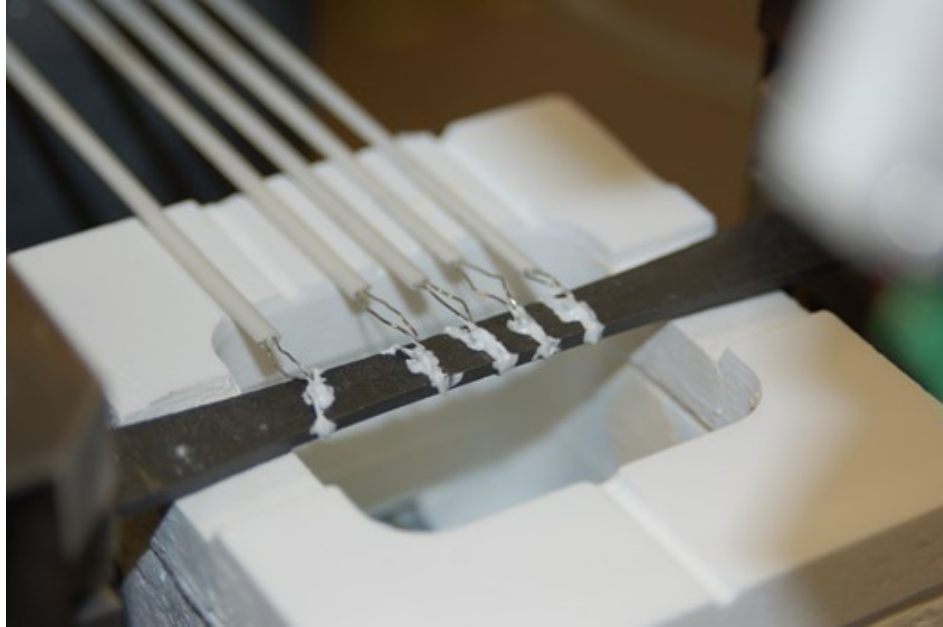
Figure 25. Photo of a CMC test specimen instrumented with thermocouples for furnace temperature mapping
